# Raised Rehab

A rehabilitated lift bridge completes 100 years of Erie Canal service and is poised for another 100.

## STEEL CENTURIONS SPANNING 100 YEARS

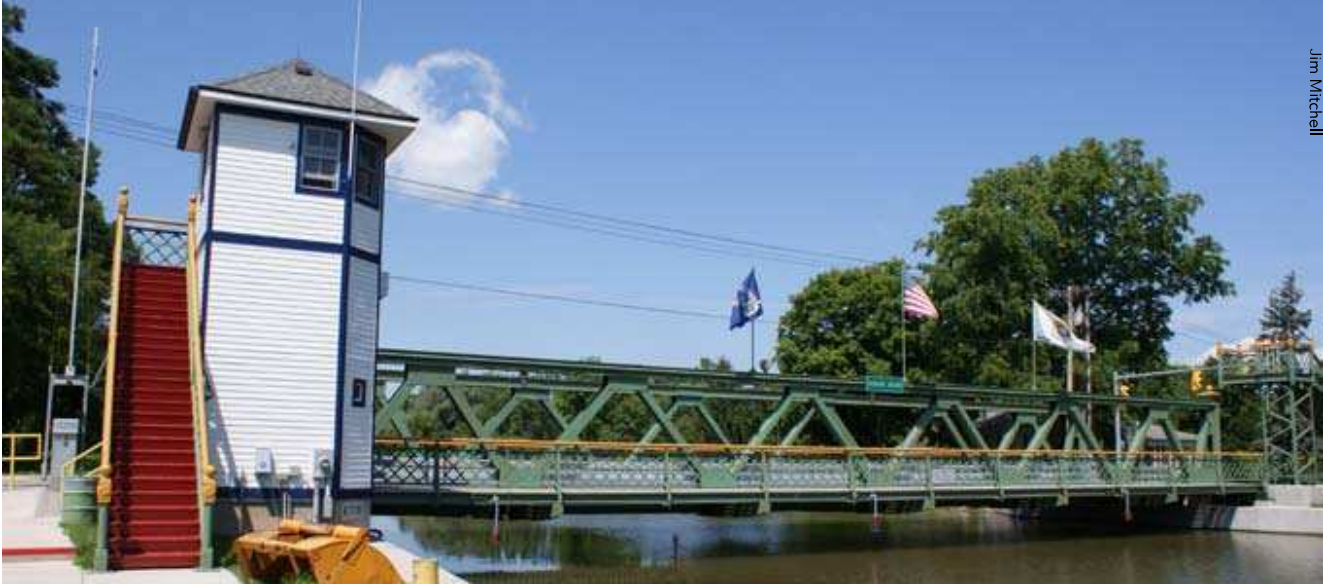
◀ The Washington Street Lift Bridge turned 100 this year.

Structurally, the design of the Washington Street Bridge is a rivet-connected Warren pony truss. The bridge has a total length of 144.7 ft and a deck width of 18.4 ft. The Warren truss consists of diagonal members only—no verticals. The term "pony" means that the truss has no bracing between the top chords. The word "Cambria" stamped on the bridge indicates that the steel came from the Cambria Steel Works in Johnstown, Pa. (the same plant that supplied the Greenspot Road Centurion bridge in the June issue).

The lift mechanism used is relatively unusual. Vertical end posts extend below the deck and into the ground. When operated, the end posts rise out of the ground. Stairways from the sidewalks at each end of the bridge allow pedestrians to continue to cross the bridge even when it's in the raised position. Raised, the bridge provides about 15 ft clearance over the water. Interestingly, the operator of this bridge also works the Union Street Lift Bridge about two miles down the canal in Spencerport; the operator drives to the Washington Street bridge when notified of a boat needing to pass.

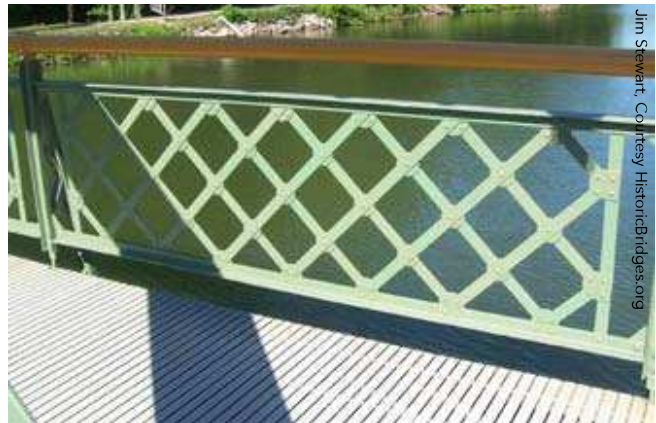
- ▲ Railing for one of the pedestrian walkways. Thanks to stairways, pedestrians can cross the bridge even in its raised position.
- ▼ Mill marking for the original steel.
